# Summary of Events 2015–2022

A continuation and conclusion of **Summary of Events 2008-2014**

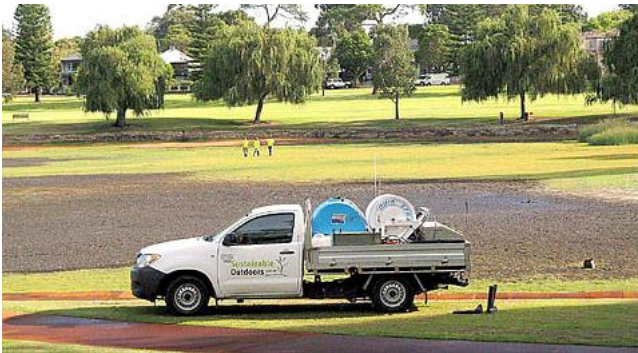
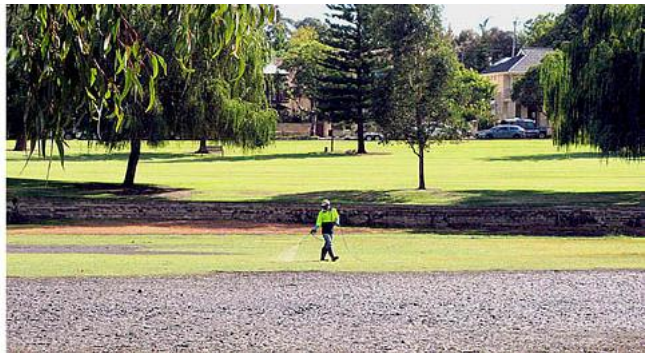
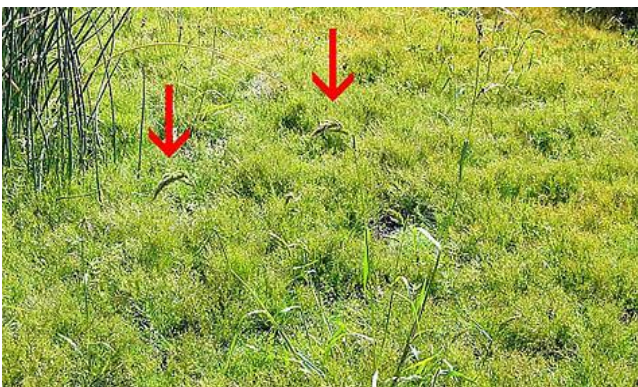
**Above:** It is 25 March 2015. Even the highest flood in 30 years has quickly leaked away. The lake has dried up, noxious weeds have taken over the dryer parts, and spraying is once again necessary.

**Left:** Of course spraying has to avoid established reeds and sedges, but under this protection nearby noxious barnyard grass with its thick seed heads (arrowed) is surviving. Barnyard grass can reach more than waist height (p.17 of Pt 1), so spraying is the price to be paid for returning an urban lake to a "natural ephemeral wetland" (which by definition excludes permanent water as a natural deterrent).

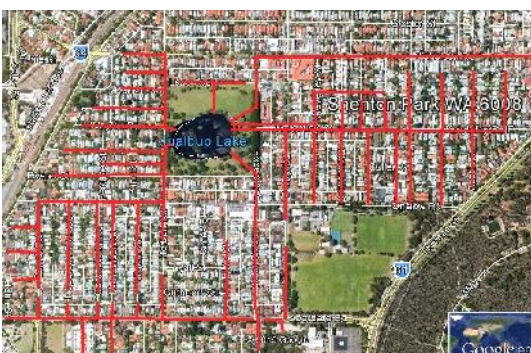
Blue squares show the soak wells installed at April 2016. More are planned.

Their effect on runoff into the lake is shown on next page

Soakwells on the roads leading to outlet 2 have more or less eliminated the runoff into the lake.

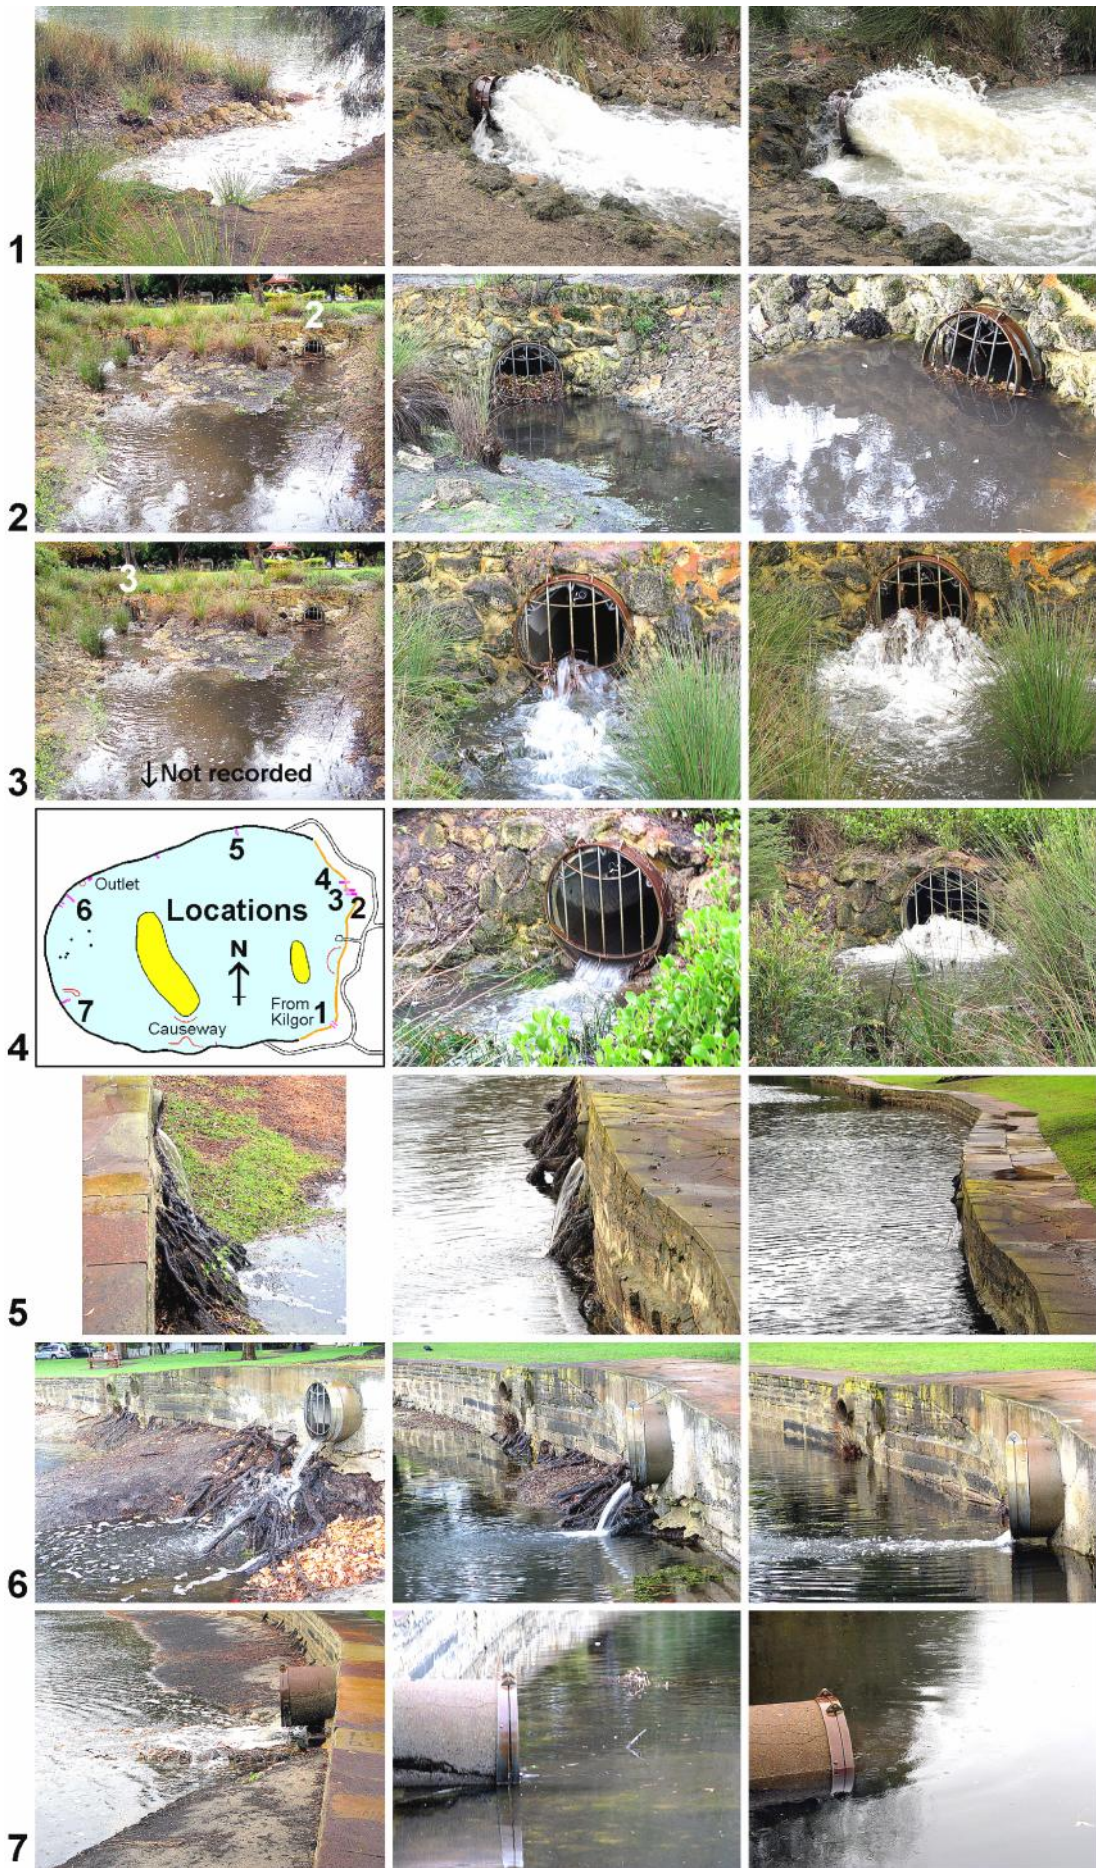
16 May 2015 noon during steady light rain

19 Aug 2015 5pm after 8mm in 75 min

21 Aug 2015 noon after 15mm in 60 min

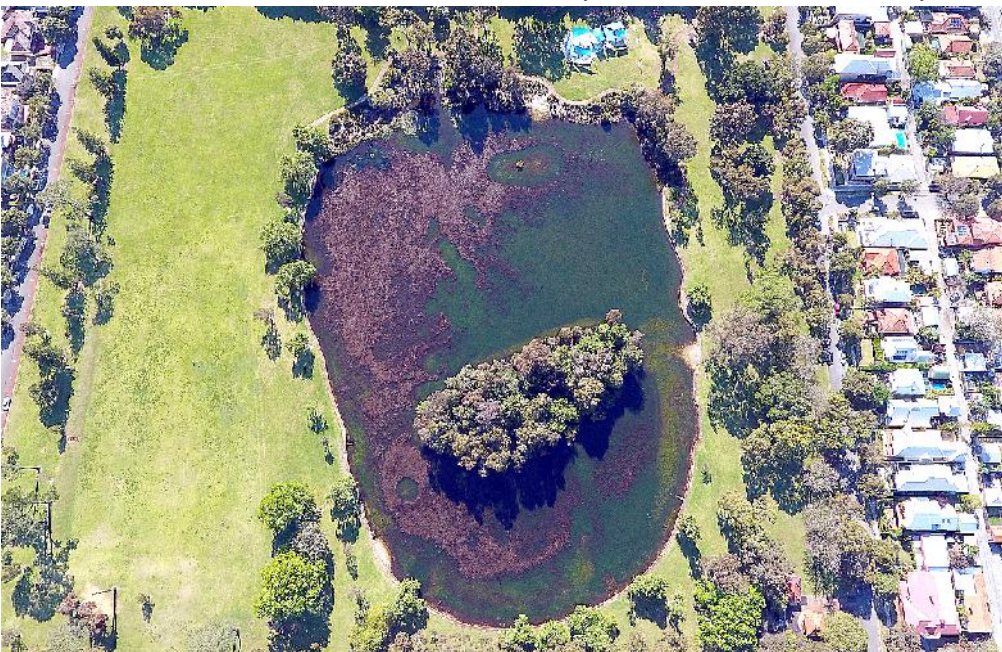
September - This stunning vertical shot was taken by Bellcourt's drone and is reproduced courtesy of Kirk Bellerby. Brownish areas are floating debris from Kilgor Park Lake outlet at top right. Note dense vegetation on island. In bottom half, pale areas near the edge are sandy areas free of dark mud. Surroundings are an urban park, not native bush!

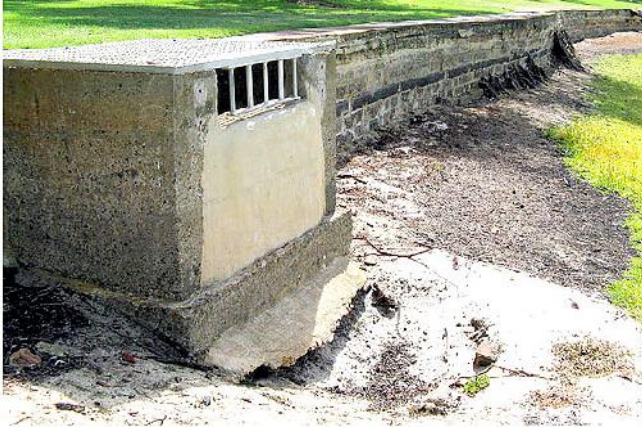
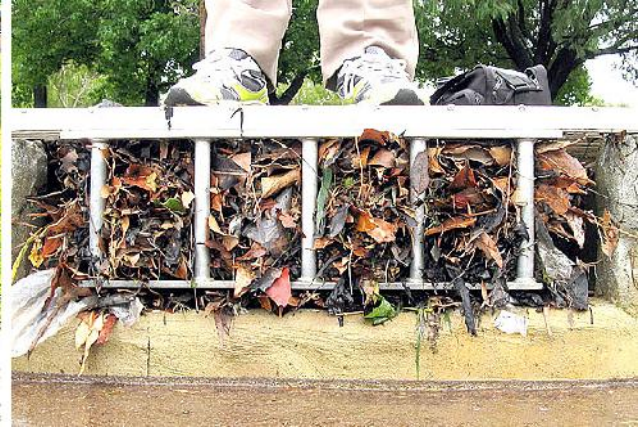
The same record rainfall leads to a flow reversal *into* the lake through what should have been the *outlet*, scouring away the sand below and leaving packed leaves and twigs *behind* the outlet grille..

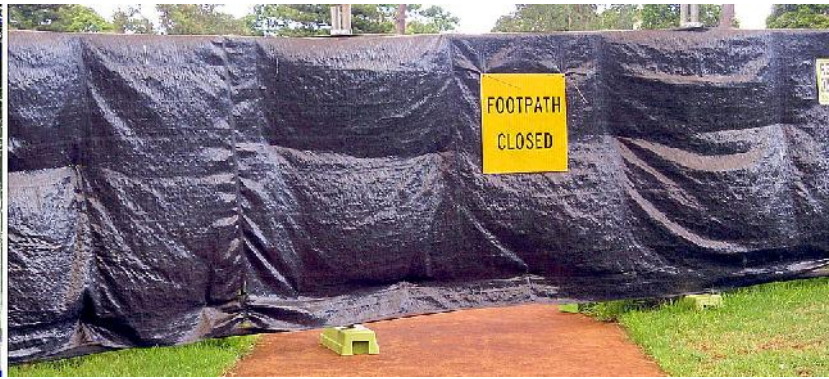
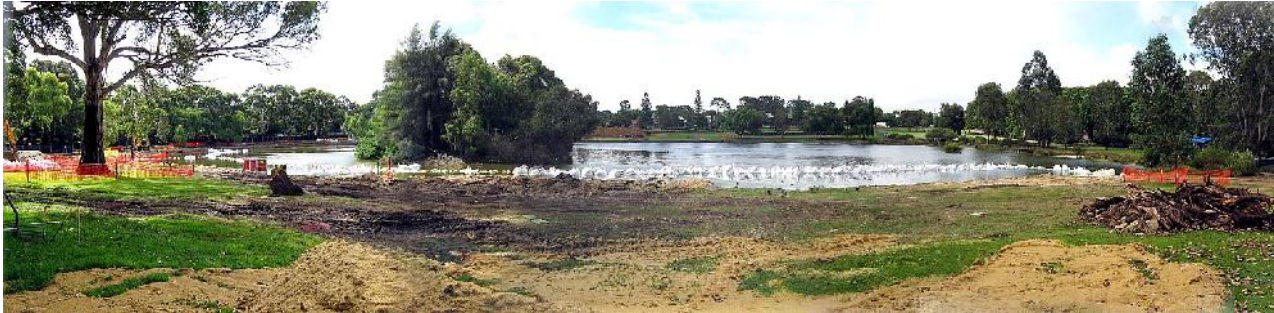
Upgrade work begins November 2017. A fence keeps dust in and intruders out. The old wall and paved path are removed ready for the new. A row of sand bags and pumping stop water intruding.

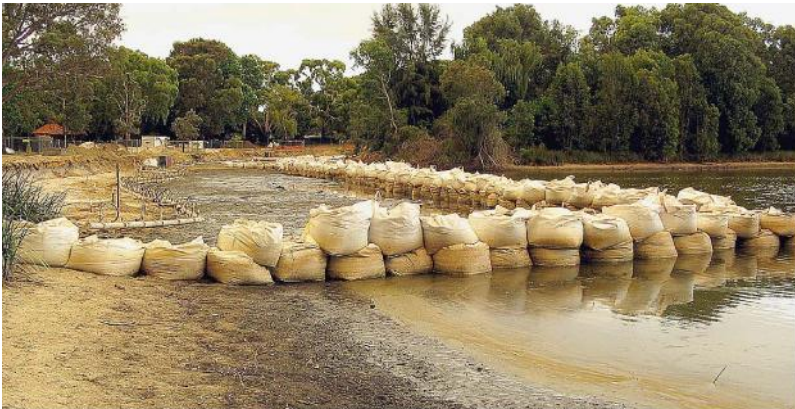
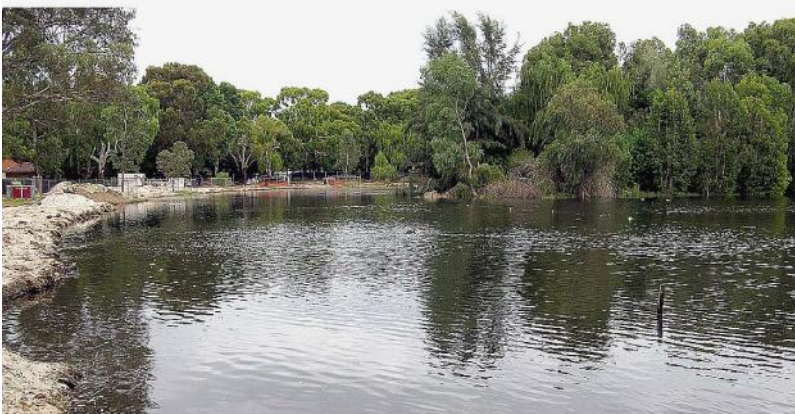
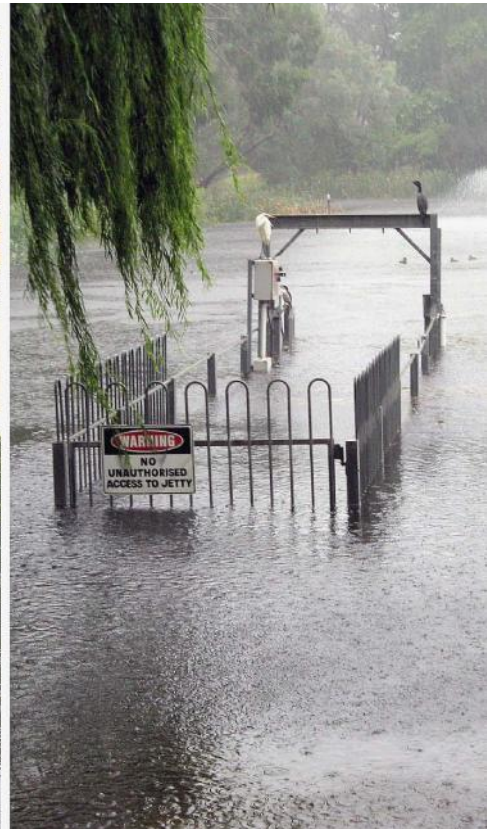
14 January 2018. Giant sandbags placed and moved by crane failed to keep water out because it seeped through the underlying sand confirming its permeability. But the lake is soon dry enough for laying the foundations of the new wall. 15-16 January a cyclone up north brings 124mm of rain (measured locally) all helped by floodwater pumped from Kilgor Park Lake (above right). It fills the lake to overflowing leaving only the tips of the biggest sandbags barely visible above water. The rise in water level from what were a few residual puddles to overflowing is 1.8 metres. It takes two weeks of pumping in business hours to return the lake to a state where work can continue. Shortly after, the contractor BCL goes into liquidation (no fault of Subiaco's) and is replaced by CivCon.

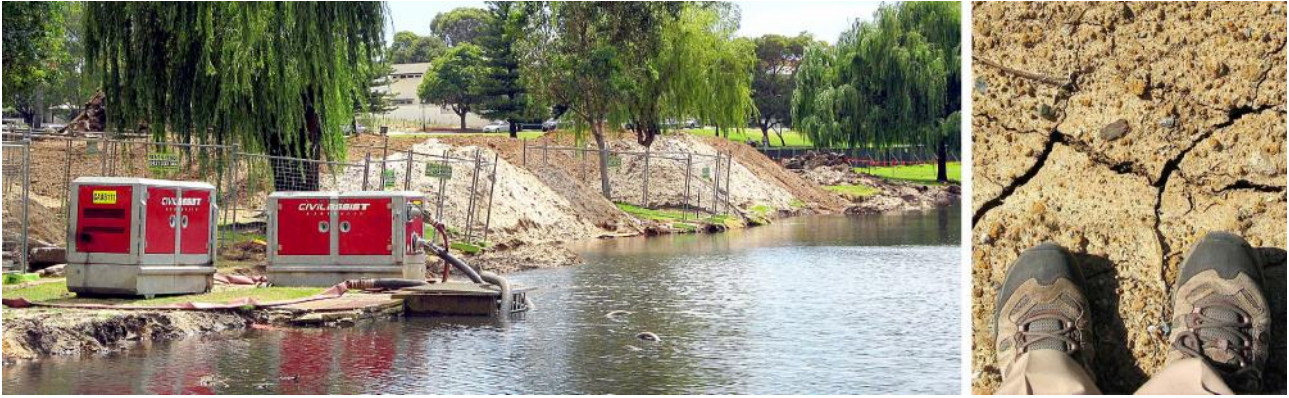
Each pump (red boxes) discharges 50kL a second down the outlet. The mounds in the background are natural clay mix ready for use. Their clay content is confirmed by cracking as it dries after rain.

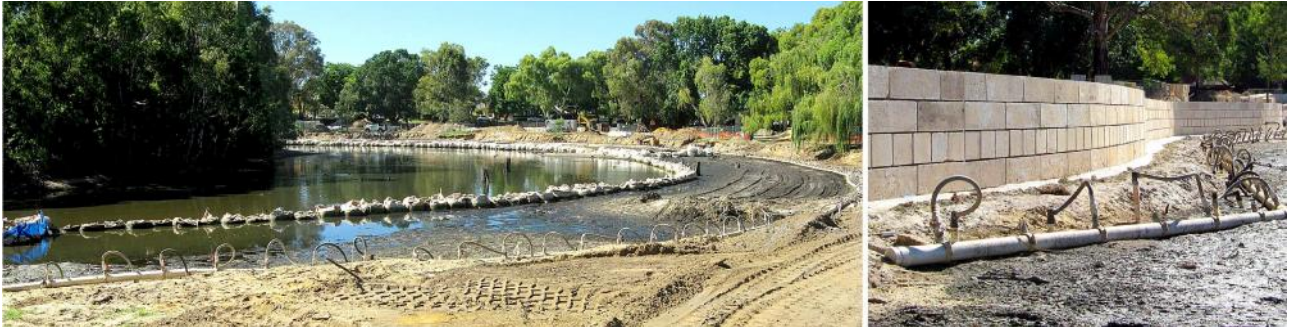
The pumps remove water via pipes to which are attached long spikes driven into the groundwater.

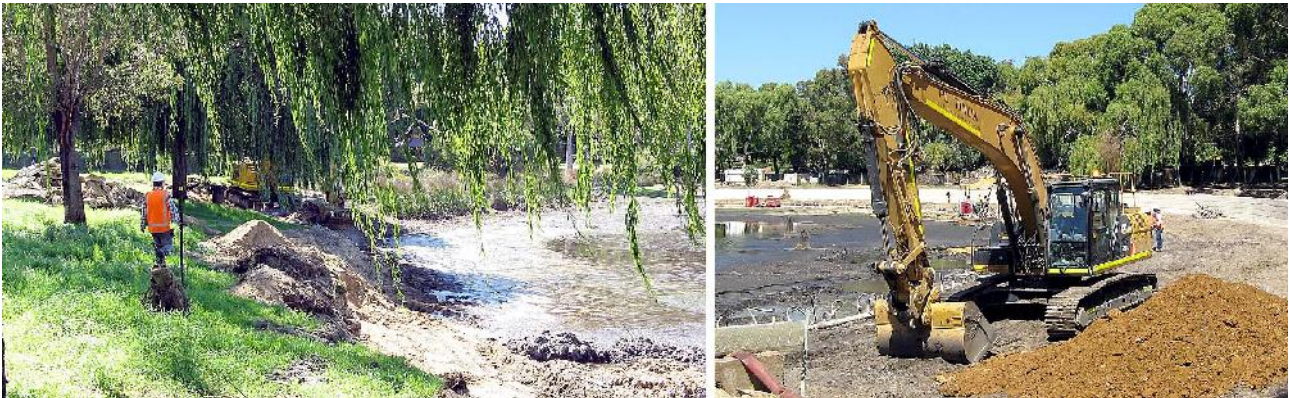
Noongar Land & Culture Protector Iva Hayward-Jackson (in red) inspects the diggings for possible human remains as required by law. None were found confirming that the area was not a burial site.

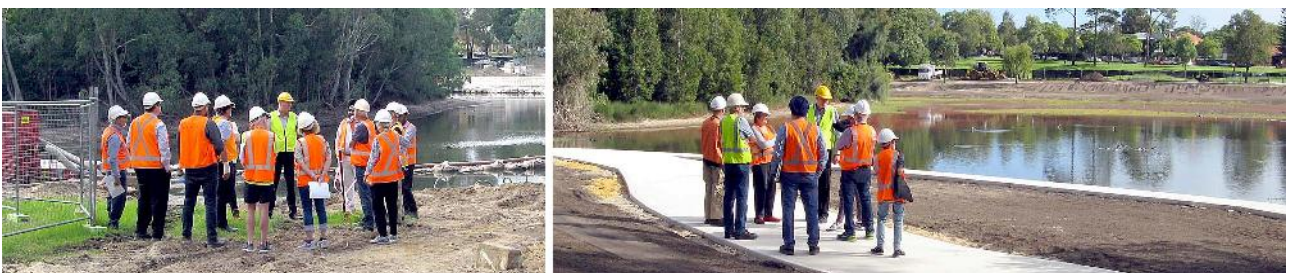
Subiaco staff give Save Our Jewel the opportunity to view progress and ask questions. In yellow facing camera is Gray Stead, Director of Technical Services. **Left** 6 February. **Right** 10 April, where across the lake the sloping banks are covered by cloth mesh to prevent erosion until established.

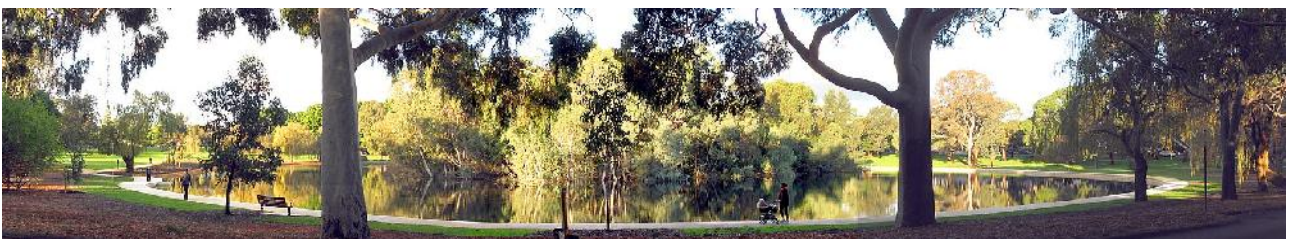
Looking W: New sloping banks on left, new wall and path on right. The compromise is well received.

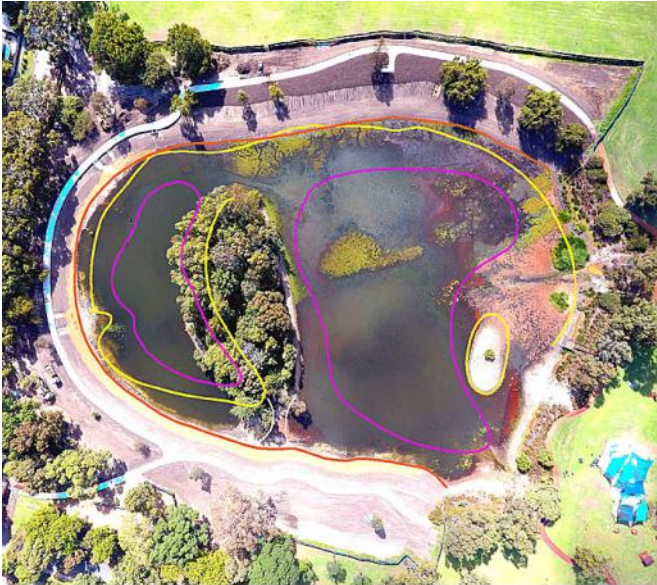
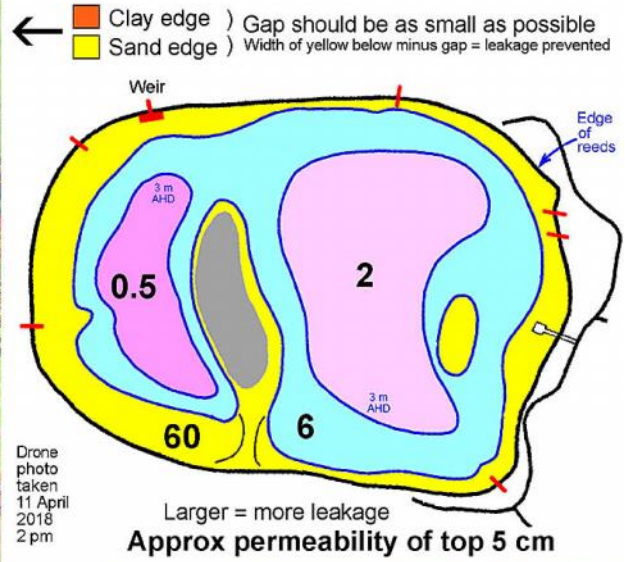
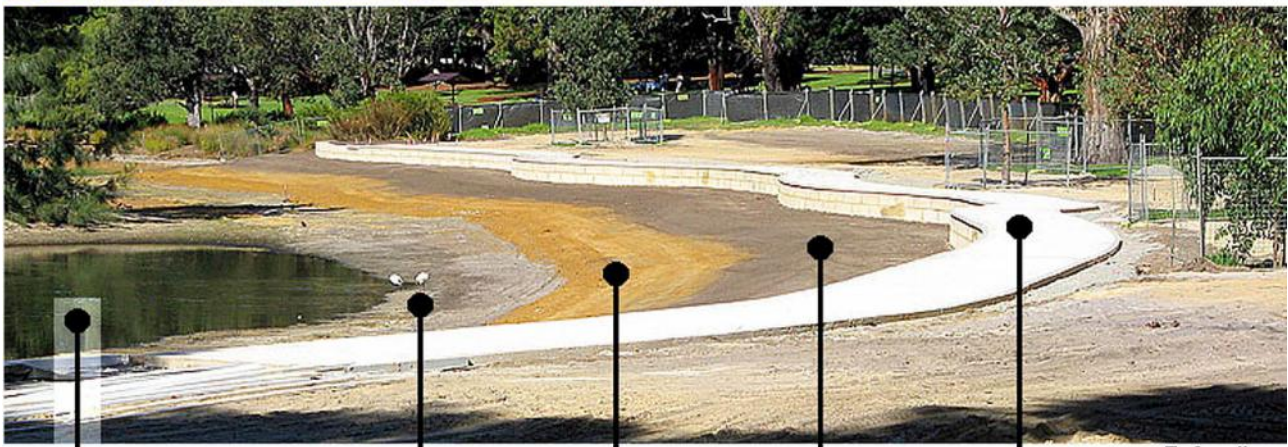
Water    Original lake bed    Clay layer    Soil layer    New path    5 April 2018

**Above:** The clay layer covers all but the E end of the sandy perimeter (in yellow) through which most of the lake water was leaking. The reduced leakage would slow the loss of water in summer but not prevent it, so the seasonal variation in level would be retained to encourage bird and plant life. The soil is for the planting of reeds and sedges. **Below:** 584m of new wall uses 3700 limestone blocks. In total 14,000 sedges and another 7000 natives are planted, and 4600m<sup>2</sup> of turf are laid.

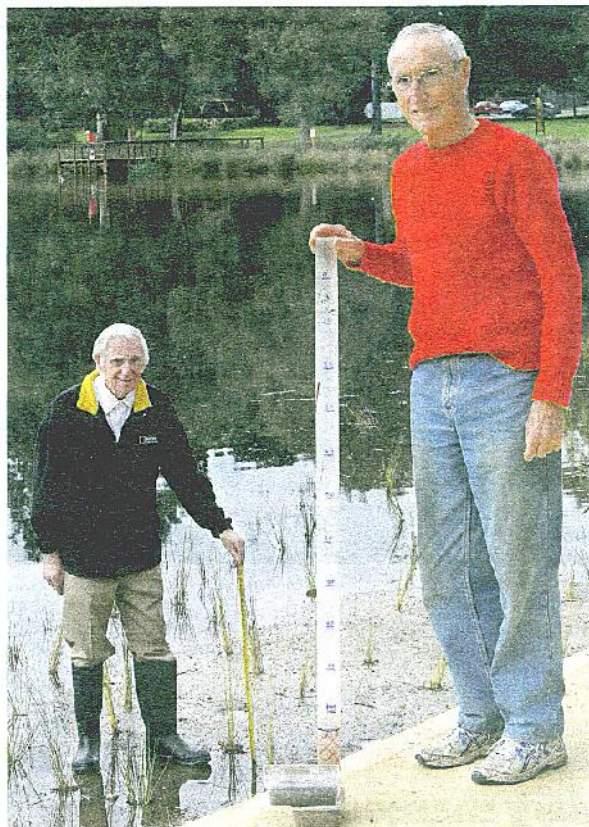
**Eureka ...** Dr Geoffrey Dean takes yet another depth measurement in Lake Jualbup, while Hugh Richardson shows the long tube used to time how fast lake water seeps through sand and mud. **Photo: Billie Faidough**

Water went through the sand at least 10 times faster than through the clay. They had their answer.

The lake was losing water not through evaporation or through its muddy bottom, but 80% through a porous 10m-wide fringe of sand.

The answer was to mix clay with soil – to provide a base for the thousands of reeds and sedges planted around the rim, and keep the water from seeping out.

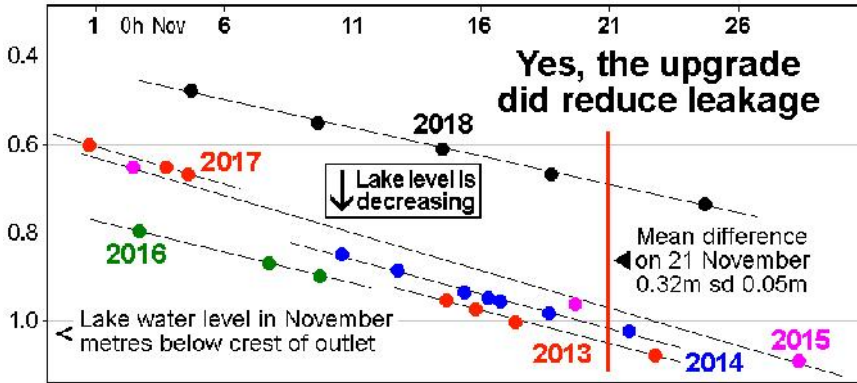
Lake Jualbup water levels during the days of November BEFORE and AFTER the council upgrade.

Compared with the 5 previous years, the upgrade has reduced leakage and made the water more than 0.3m deeper. So the upgrade worked as planned and can be counted a success.

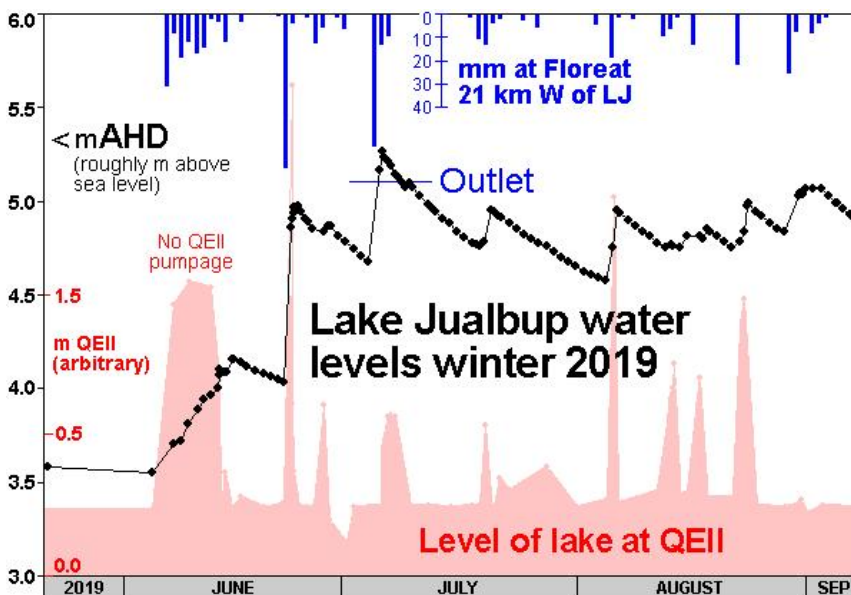
This next plot shows how the lake level increases as the rain falls (not just the rain falling on the lake but also the larger amount arriving via drains from the surrounding roads), and also with the level of the lake at QEII (the overflow is pumped to Lake Jualbup since the lake has no outlet of its own).

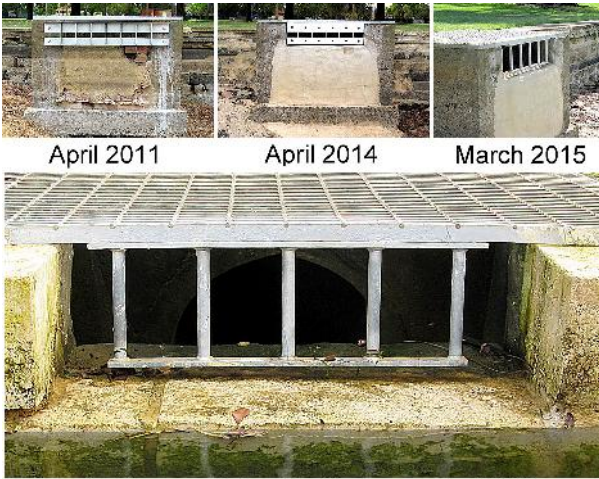
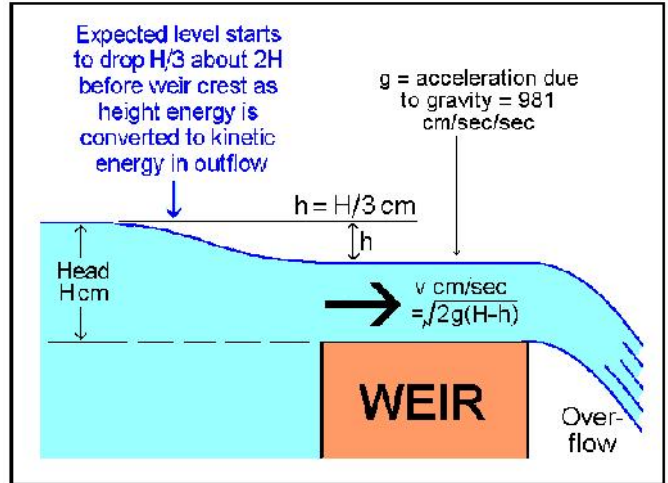
Jualbup outlet weir after upgrade 2018

Back at Lake Jualbup, the outlet has been refurbished several times. In the bottom picture above (taken from a canoe) the water level is just below the edge of the masonry. Despite the refurbishing the outlet level is not affected. Nor are the outflow dynamics, which allow the rate of discharge to be estimated by measuring the head as shown (easily done by temporarily blocking the outflow).

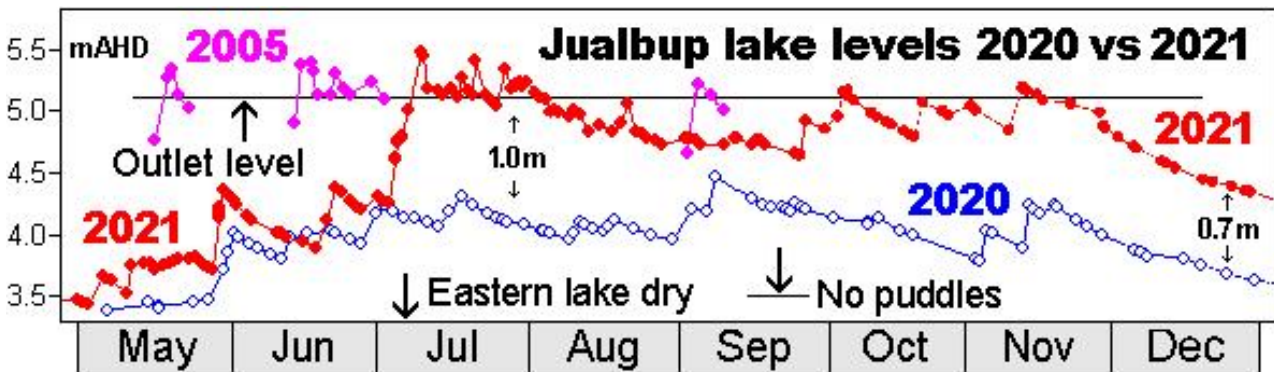
Happily 2021 was quite the opposite. The above plot shows what happened. Heavy rainfalls in July and again in October and November caused the lake to overflow on 30 separate days, beating the high of 20 separate days in 2005.

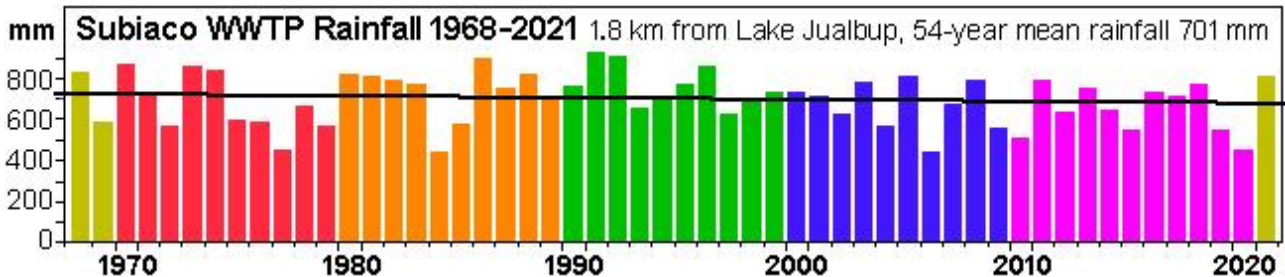
**Above:** This picture of storm clouds over Lake Jualbup is to remind us of the crucial importance of rainfall, in particular the importance of both amount and timing as shown by this graph of annual rainfall 1.8 km away at the Subiaco Waste Water Treatment Plant since records began in 1968:

The slow decline in total rainfall over 50 years (about 1 mm a year) is swamped by the much larger variation (typically 200 mm) from one year to the next. The upgrade had to deal not only with the variations in annual rainfall but also with the equally large (and equally unpredictable) variations in timing during a given year. The plots below step you through these variations over the past dozen years. Start top left and proceed in year order. Below each year is the total annual rainfall.
